STOP THE ROT

Report II: Rapid corrosion of handpumps

ACTION RESEARCH ON HANDPUMP COMPONENT QUALITY AND CORROSION IN SUB-SAHARAN AFRICA

Dr Kerstin Danert

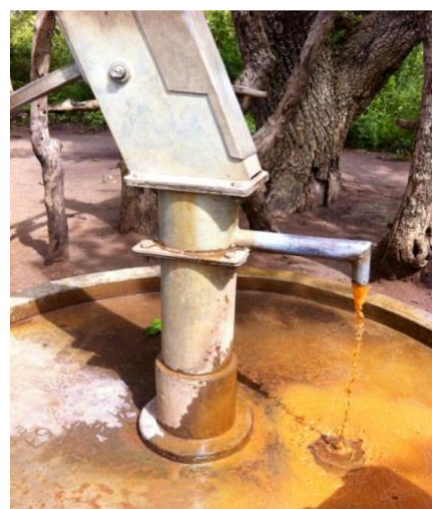
The high turbidity of the water from a corroding handpump that has not been used for some time (e.g. overnight) can be caused by the accumulation of corrosion products. Discolouration of the water to red/brown a few minutes or hours after pumping is due to the transformation of ferrous iron to iron hydroxides and iron oxides when exposed to oxygen in the air. User perceptions of taste, smell and appearance (especially if the water is red after the handpump has not been operated for some time, or if the colour of the water clears after minutes or hours of pumping), changes in turbidity over time (i.e. deterioration over weeks and months), and pumped clear water that turns red after some time are all indicators of handpump corrosion.

FIGURE 4 RED, IRON-RICH WATER BEING PUMPED

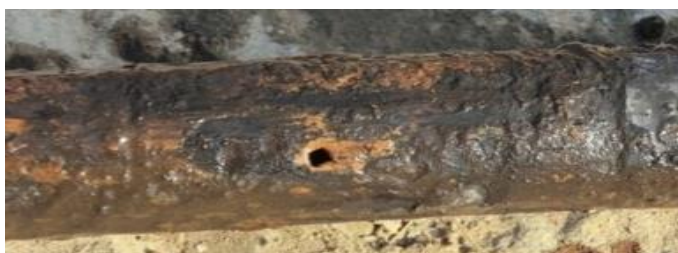
Once corrosion causes holes in the pipe such as pitting (Figure 5a, 5b and 6a), gaping holes (Figure 6c) or damaged threads (Figure 6d), the pipes start to leak. As a result, water flow is reduced (or completely eliminated) and handpump performance reduces. More effort is required in terms of pumping to draw up water from underground. Leakage from the riser pipes also means that it takes longer to prime the pump for use after it has not been used for some time (WaterAid, 2021). Corrosion of riser pipes and pump rods can also lead to outright failure, including riser pipes dropping into the borehole due to damaged threads (Figure 6d).

(a) Riser pipe corrosion in Zambia
Source: SOMAP3, 2013.

FIGURE 5 PITTED RISER PIPES FROM CORROSION IN ZAMBIA AND NIGERIA

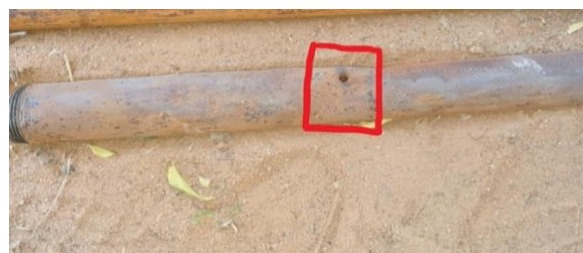
(b) Riser pipe corrosion in Nigeria
Source: Olajide Oyetunde.

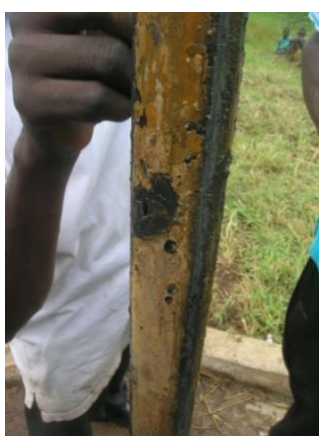
(a) Removal of pitted pipes within, Hoima District, Uganda, 2012
Source: Larry Bentley.

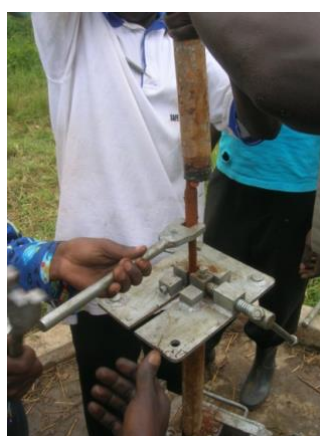
(b) Removal of corroded pump rods and riser pipes in Hoima District, Uganda, 2012
Source: Larry Bentley.

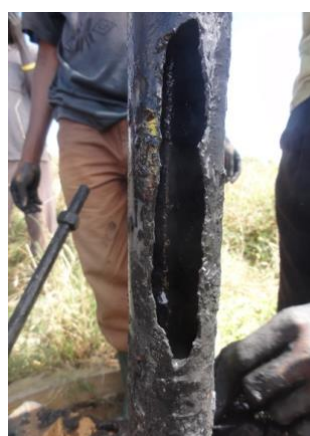
(c) Removal of corroded pipes
Source: Richard Carter.

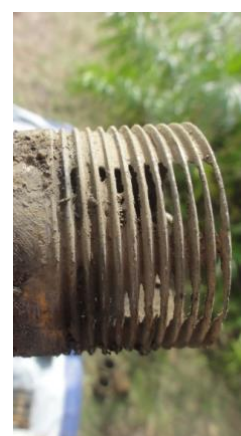
(d) Corroded pipe thread
Source: Richard Carter.

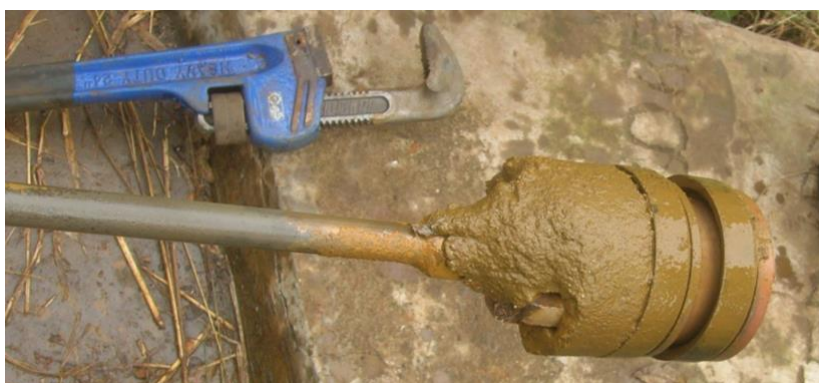
FIGURE 7 FOOT VALVE COVERED WITH DEBRIS FROM CORROSION

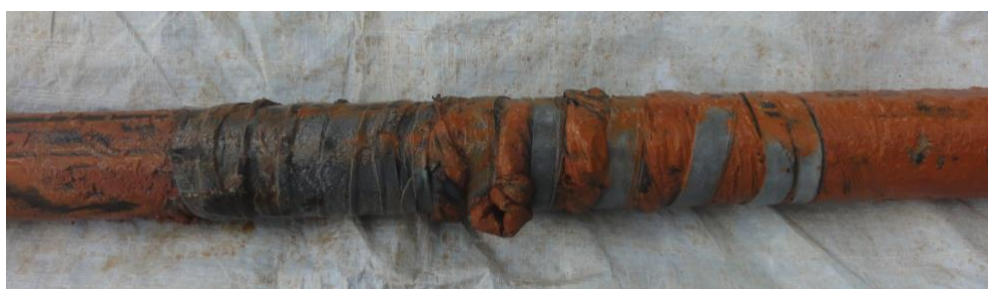
FIGURE 8 CORRODED RISER PIPE WITH BIOFILM AND REPAIRS USING AN INNER TUBE IN AMURIA, UGANDA

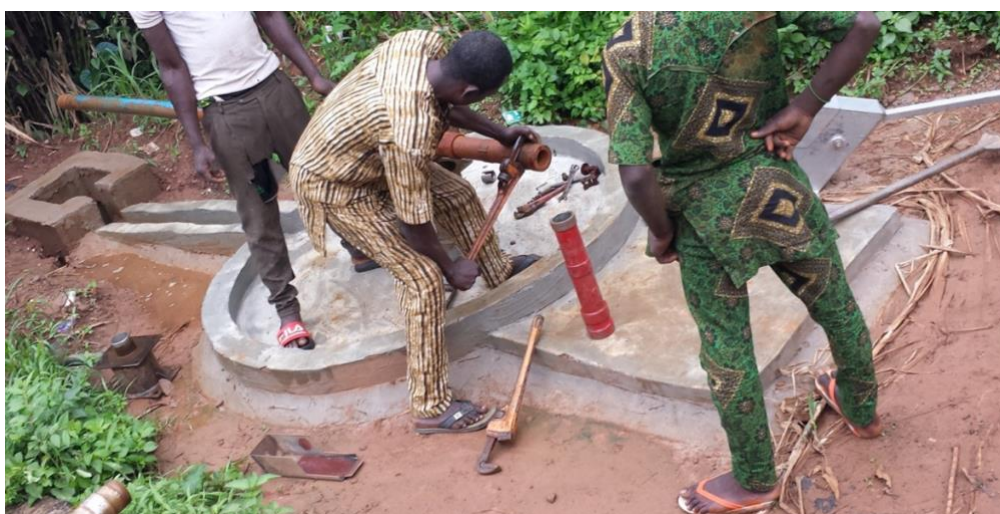
FIGURE 9 CHANGING RUSTED CYLINDER IN OSUN STATE, NIGERIA

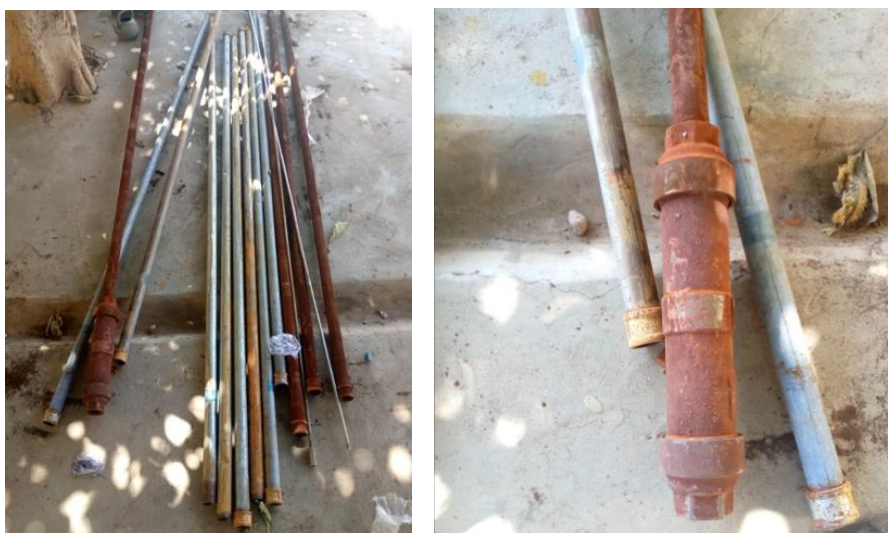
In the case illustrated in Figure A2.3., the handpump was initially installed in 2019 and rehabilitated in 2021. The photos indicate rapid corrosion or point to the installation of second-hand parts in the first place.

FIGURE A2.3 PHOTOGRAPHIC EVIDENCE OF RAPID HANDPUMP CORROSION IN KATSINA STATE, NIGERIA
