STOP THE ROT

Report II: Rapid corrosion of handpumps

ACTION RESEARCH ON HANDPUMP COMPONENT QUALITY AND CORROSION IN SUB-SAHARAN AFRICA

Dr Kerstin Danert

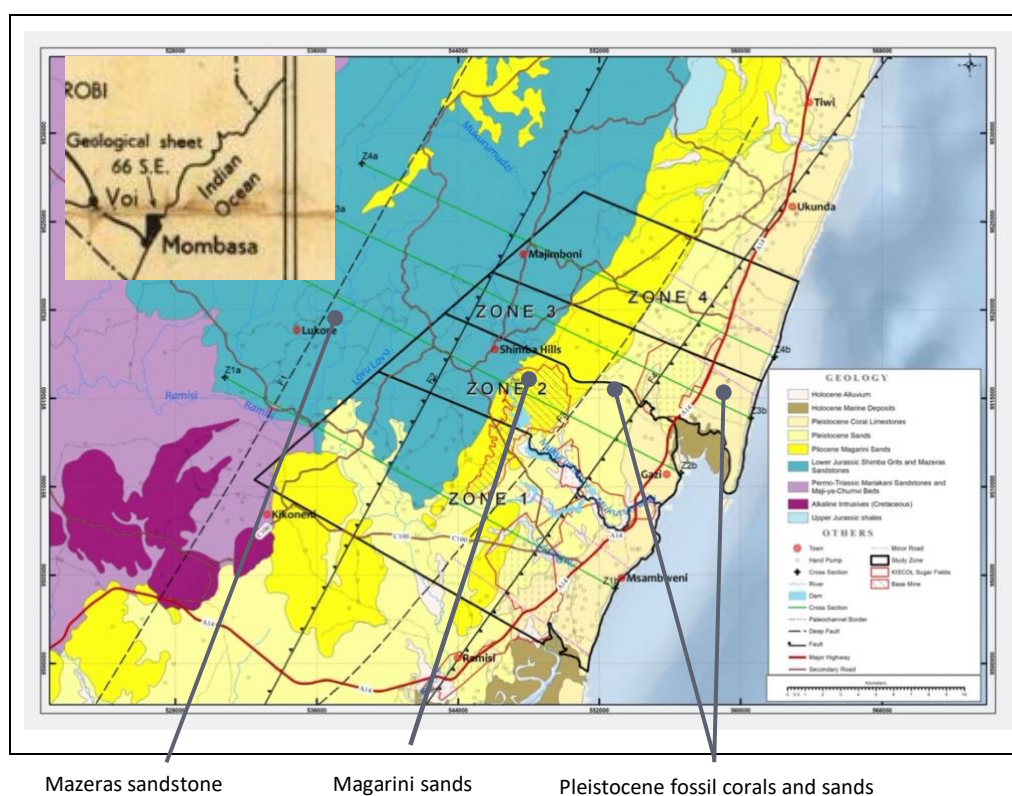
FIGURE A2.1 GEOLOGY OF THE MOMBASA-KWALE AREA WITH IRON-RICH AREAS INDICATED

Moderate and high levels of dissolved iron have been found in boreholes throughout Kenya (MWSI and WRA, 2019). Corrosion of GI riser pipe and pump parts has also been observed in both shallow and deep groundwaters of the southern Kenyan coast. In some areas of Kwale (Figure A2.1), low pH has been known to cause rapid corrosion of mild steel pump rods (Reynolds, 1992).

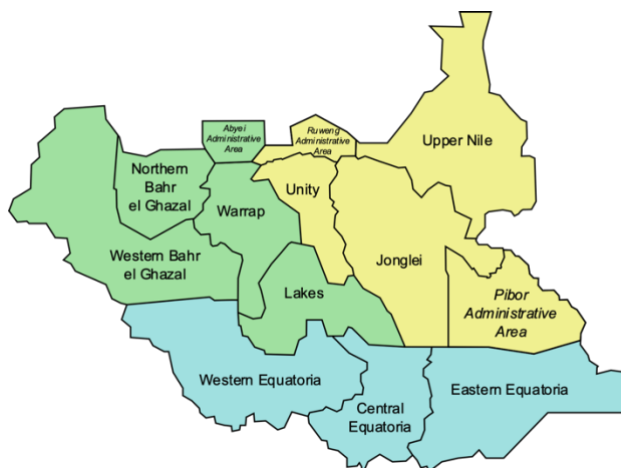
FIGURE A2.4 STATES OF SOUTH SUDAN

The corrosion of GI components on the India Mark II in South Sudan has been a longstanding problem for both water quality and the cost of the operations and maintenance (Furey, 2014).

In Northern Bahr el Ghazal state, one respondent noted that 'Most of the handpumps have their pipes rusted even some of which were repaired or rehabilitated about 6 months ago have their pipes rusted' (Furey and Danert, 2022: 17). Low pH values were also measured in a small sample of HPBs in the state (Carter and Guo, 2021).

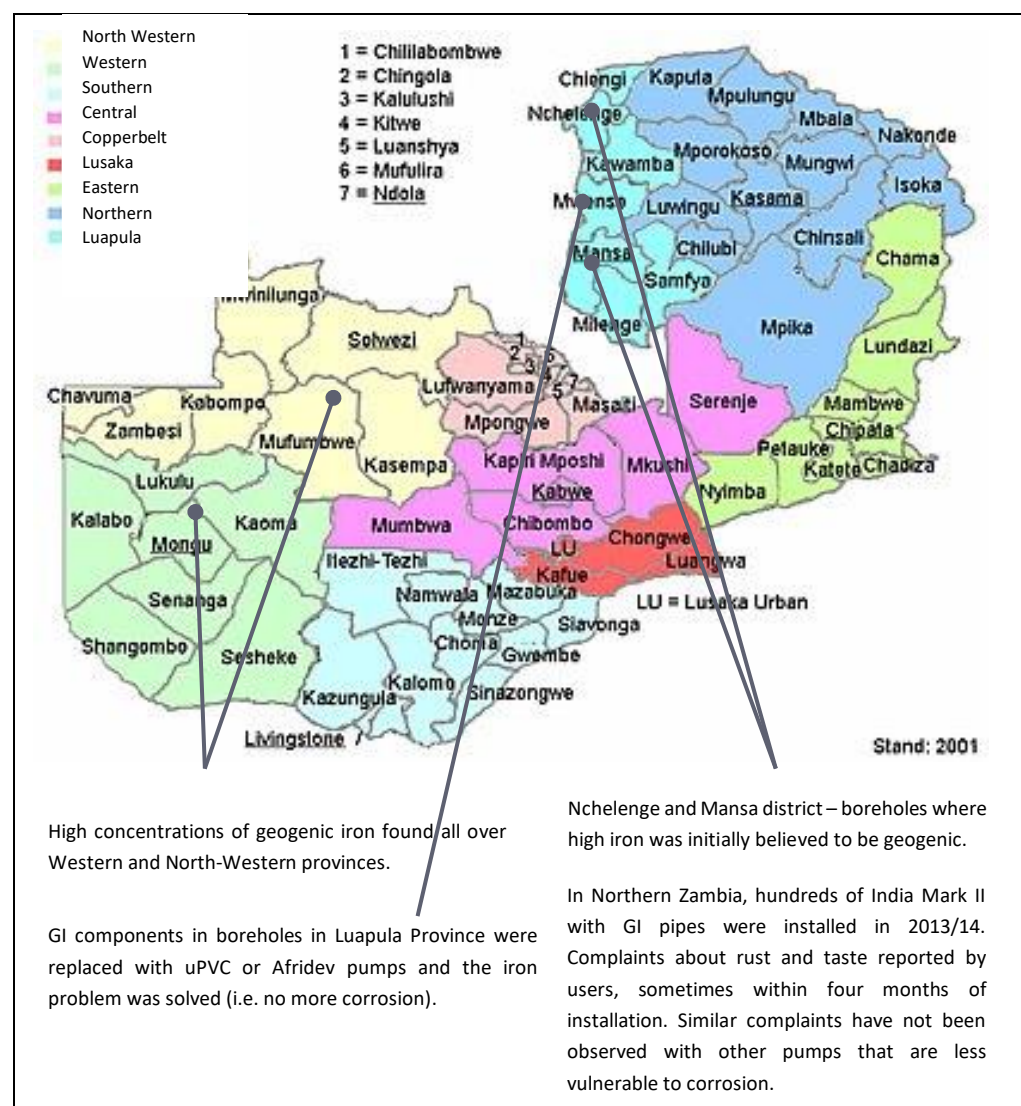
FIGURE A2.6 PROVINCES OF ZAMBIA ANNOTATED WITH AREAS OF CONCERN FOR CORROSION OR HIGH IRON CONTENT

The approved standard handpump in Zambia is the India Mark II, with variations for corrosion protection, including SS riser pipes. Afridev pumps have also been introduced on projects in certain areas (Sansom, 2009); Malda and Access 1.2 pumps are also in use (Furey, 2014). Naturally high levels of iron and corrosive groundwaters are found all over the Western, North-Western, and Copperbelt provinces (Anscombe, 2021a), which may have overshadowed the handpump corrosion problem. Determining the cause of the ‘iron problem’ for handpump supplies and taking appropriate action has therefore been a challenge. However, progress is being made in some areas. By replacing GI components with SS and PVC in existing handpumps, the two studies by JICA and UNICEF (described below) have helped diagnose the problem in some areas. However, questions still remain in some parts of the country. Dissolved iron is a common problem in Sinazongwe District of the Southern Province (Beers, 2021), but there is no conclusive evidence as to whether it natural or as a result of corrosion.
