STOP THE ROT

Report I: Handpump reliance, functionality and technical failure

ACTION RESEARCH ON HANDPUMP COMPONENT QUALITY AND CORROSION IN SUB-SAHARAN AFRICA

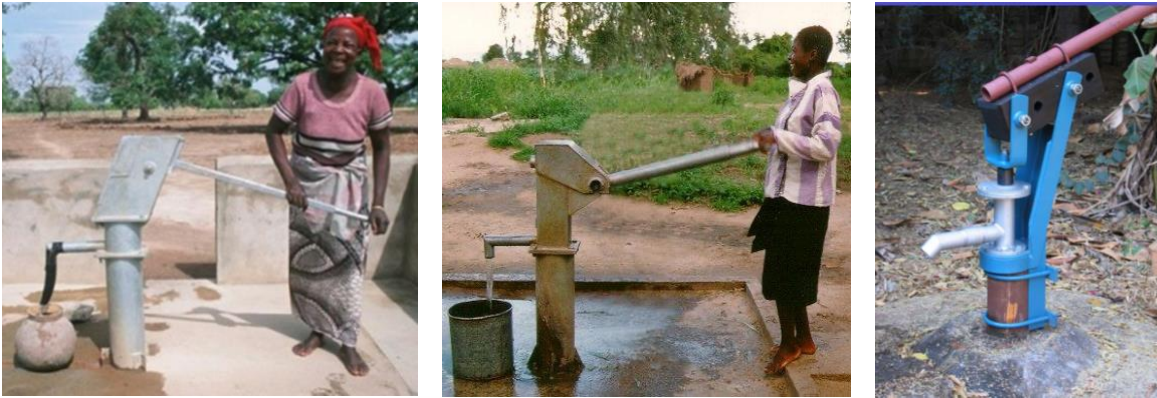
There are many different types of handpump available on the market around the world.⁸ This study focuses on two public domain community handpumps – the India Mark II (or variants thereof) and the Afridev. It also incorporates learning from the Bush Pump, which is used almost exclusively in Zimbabwe. Figure 1 shows the pump heads for these three handpumps.

(a) India Mark II
Source: Karl Erpf.

(b) Afridev
Source: Karl Erpf.

The **India Mark II Pump** is a robust conventional lever action handpump, designed for heavy-duty use, serving communities of 300 persons. The maximum recommended lift is 50 m. It is a public domain pump defined by Skat and RWSN (2007b) and Bureau of Indian Standards (BIS, 2004) specifications. It requires special skills for installation and maintenance and is not considered as suitable to be maintained at village level.

The **Afridev Pump** is a conventional lever action handpump, designed for heavy-duty use, serving communities of up to 300 persons. The maximum recommended lift is 45 m. The Afridev Pump is a public domain pump defined by Skat and RWSN (2007a) specifications. It was designed with community-based maintenance in mind.

The **Bush Pump** is a robust conventional lever action handpump, developed and standardised in Zimbabwe (Government of Zimbabwe, 2013). It is designed for heavy-duty use, serving communities of 300 persons. Three different cylinders are available, with the smallest one extending the range to a maximum recommended lift of 80 m. The Bush Pump requires special skills for installation and maintenance.

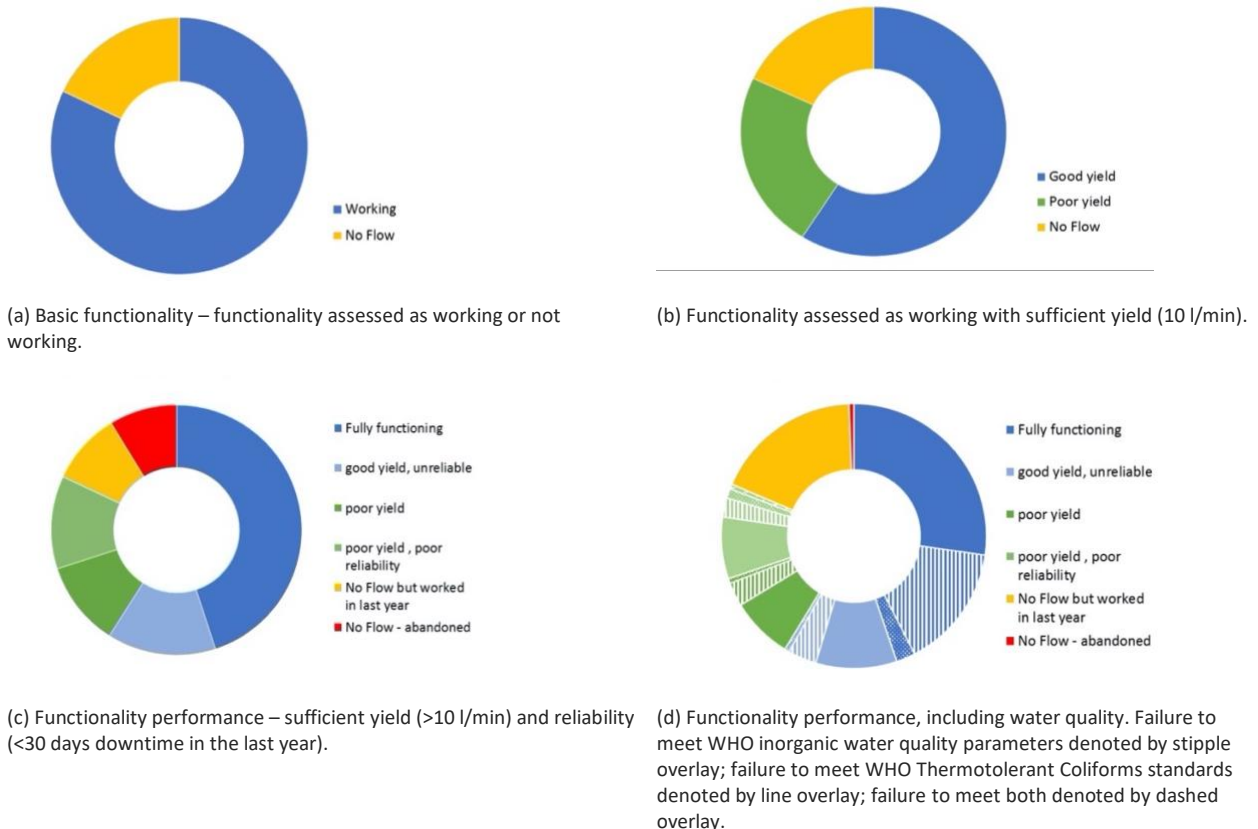
FIGURE 11 FUNCTIONALITY AND PERFORMANCE OF HANDPUMP-EQUIPPED BOREHOLES IN ETHIOPIA
 Source: Kebede et al., 2017.

A tiered approach was applied to 200 handpump-equipped borehole supplies in Ethiopia, Malawi and Uganda (Kebede et al., 2017; Mwachunga et al., 2017; Owor et al., 2017). Figure 11 shows the nuances that can be measured using this approach in comparison to the binary method. A binary approach would indicate that 82% are working, whereas the tiered approach shows that only 59% actually provide sufficient yield and only 45% are also reliable. Given that a tiered approach requires more time and resources than the binary approach, Fallas et al. (2018) recommend that a sample be assessed for different levels of performance, with good sampling design.

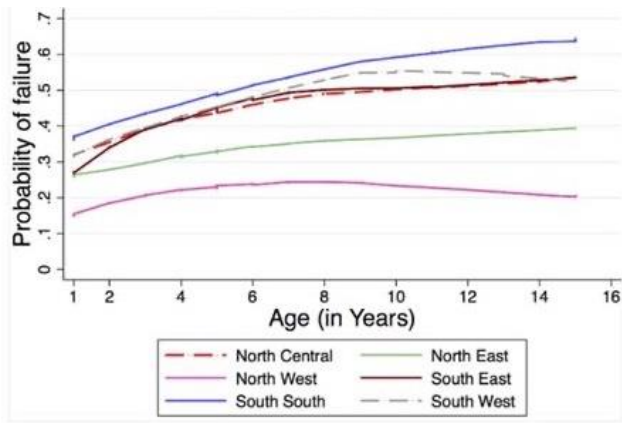
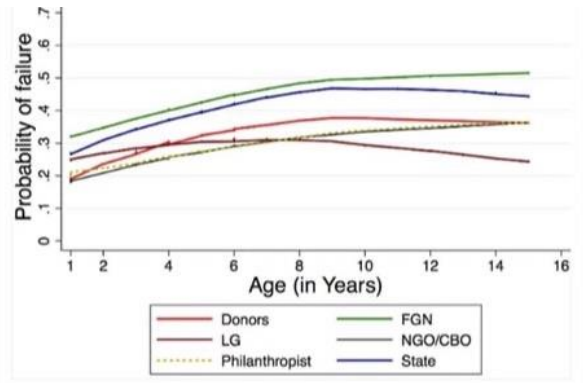
FIGURE 12 PROBABILITY OF WATER POINT FAILURE BY SYSTEM AGE IN NIGERIA

(a) Failure curve by political zone

(b) Failure curve by promoter type

- A nationwide study in Nigeria found that geo-political zones and hydrogeology had the biggest impact on functionality and that the age of installation had a significant effect, as shown in Figure 12 (Andres et al., 2018).
